Field Visit Summary Report
City of Jersey Village
Wednesday, September 28, 2016
11:00AM – 3:30PM

General Summary

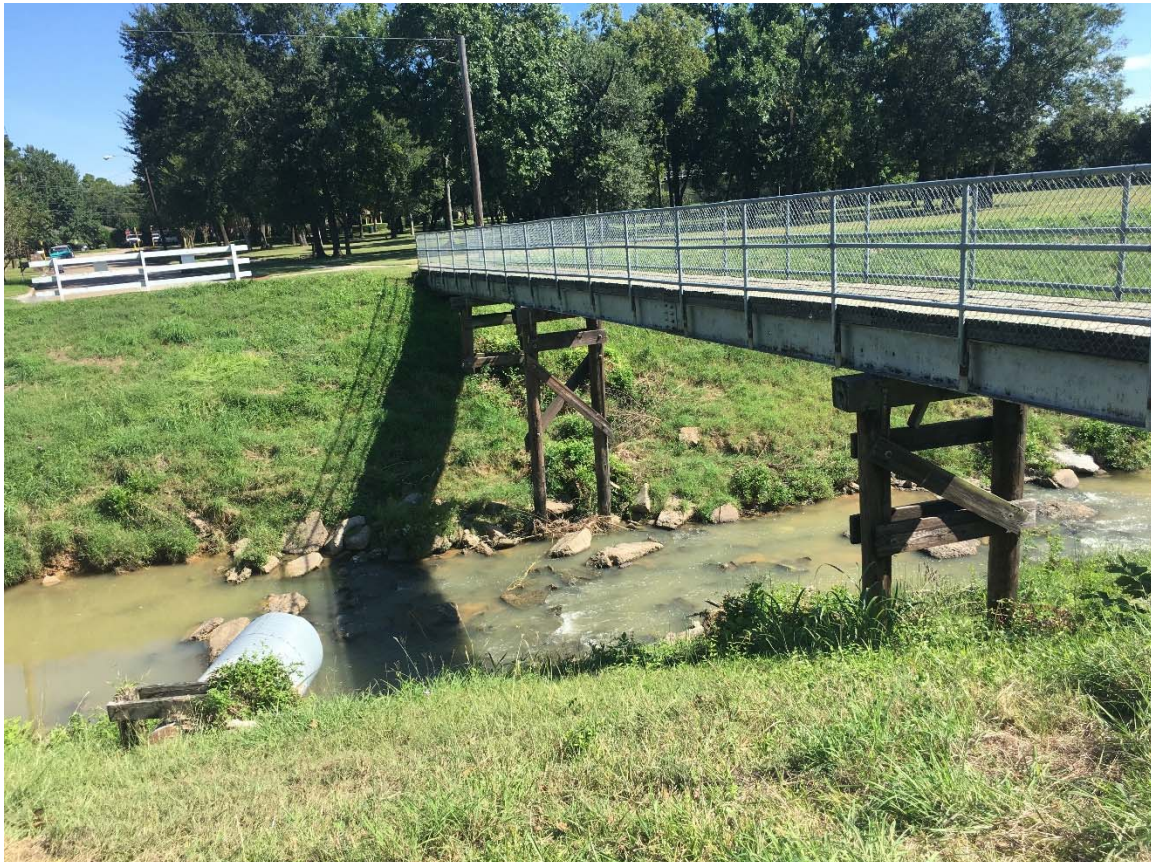
Pedestrian Bridge over White Oak Bayou @ Clark W. Henry Park

The pedestrian bridge was overtopped during the Tax Day Flood (April 18, 2016) according to City personnel. Dannenbaum observed that the bridge is a choke point for the channel and could be improved. City personnel also stated that much of the park was inundated during the Tax Day Flood.

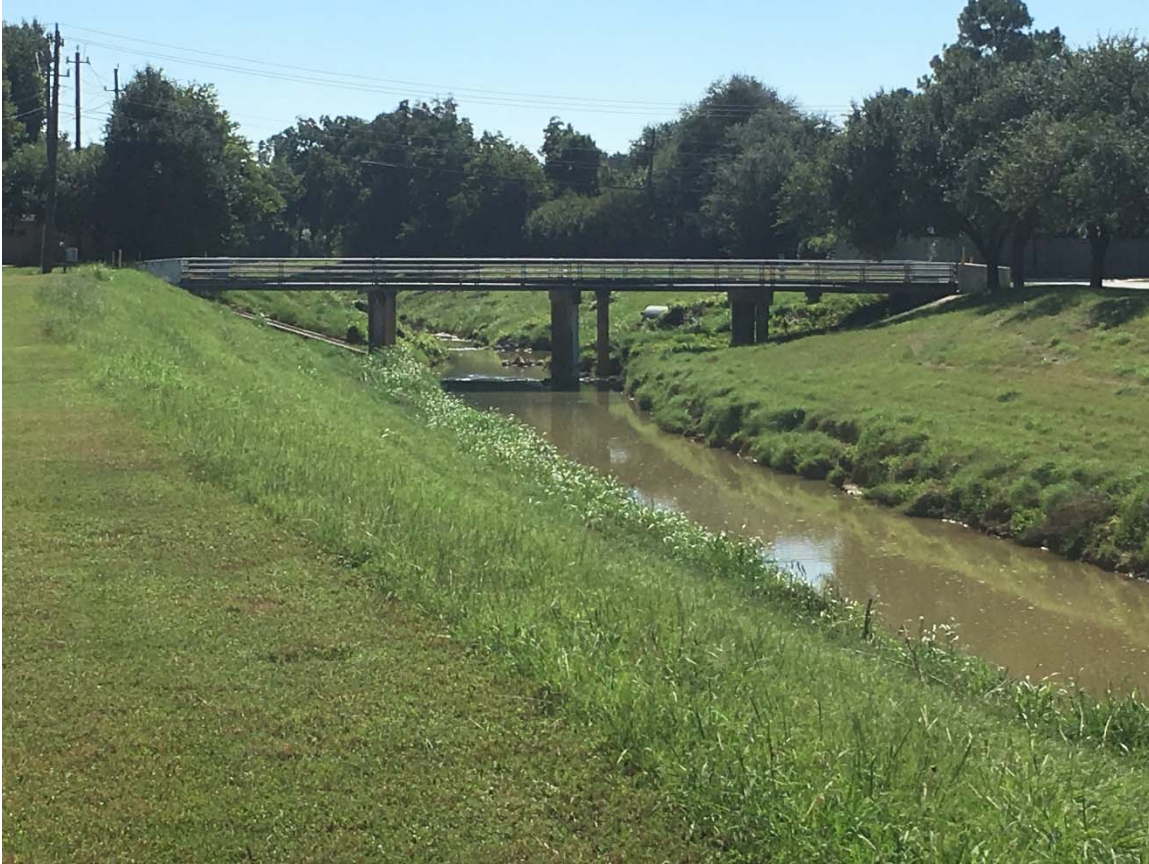
Lakeview Drive Bridge over White Oak Bayou

A waterline was observed attached to the bridge. The bridge also has a set of columns in the main channel. The columns cause losses and allow debris to build up against the bridge.

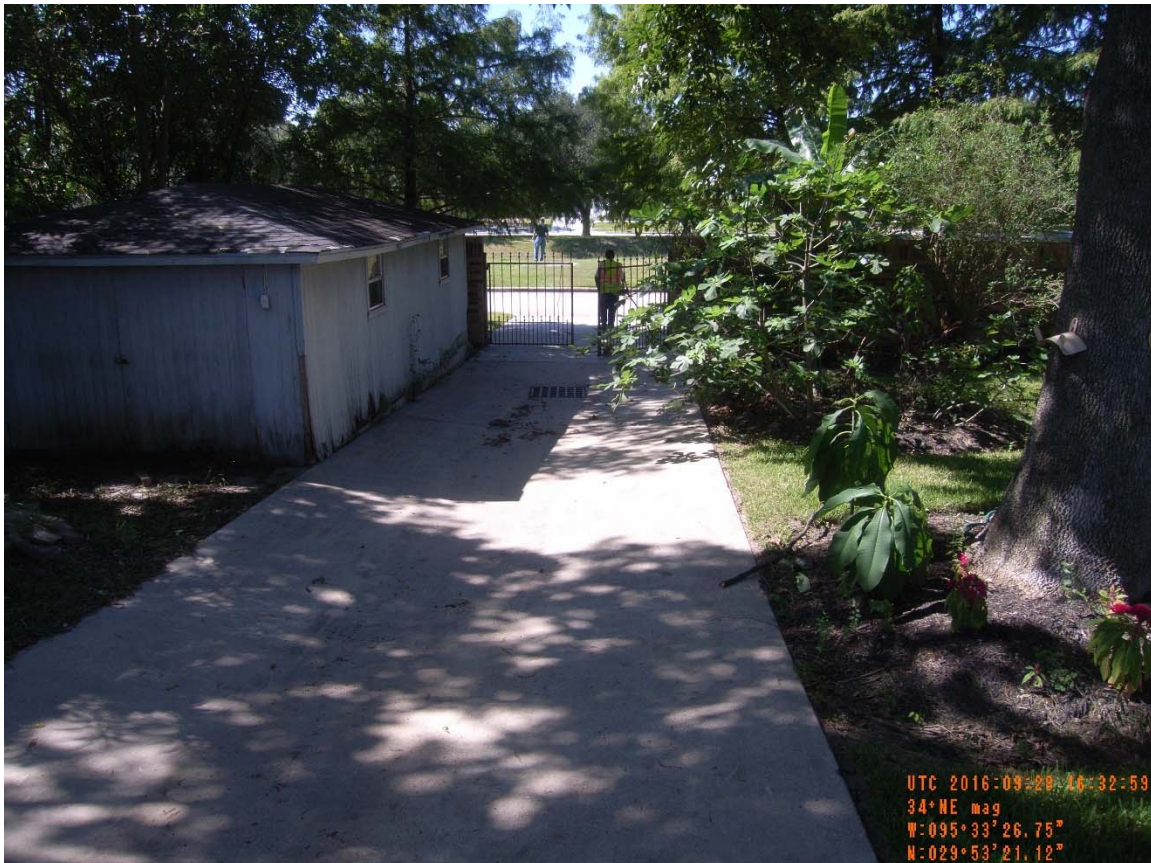
Jersey Lake Spillway onto Ginger Lane

The spillway for Jersey Lake was investigated. The permanent water surface elevation of the lake is approximately 6" below the top of the spillway. The spillway is a narrow concrete channel that connects to Ginger Lane and has an inlet for flow to enter the storm sewer system. The pipe underneath the inlet is a one-way pipe. More information is needed concerning Jersey Lake, including plans and O&M information. The lake is on private property and is not part of any City ROW or easements.

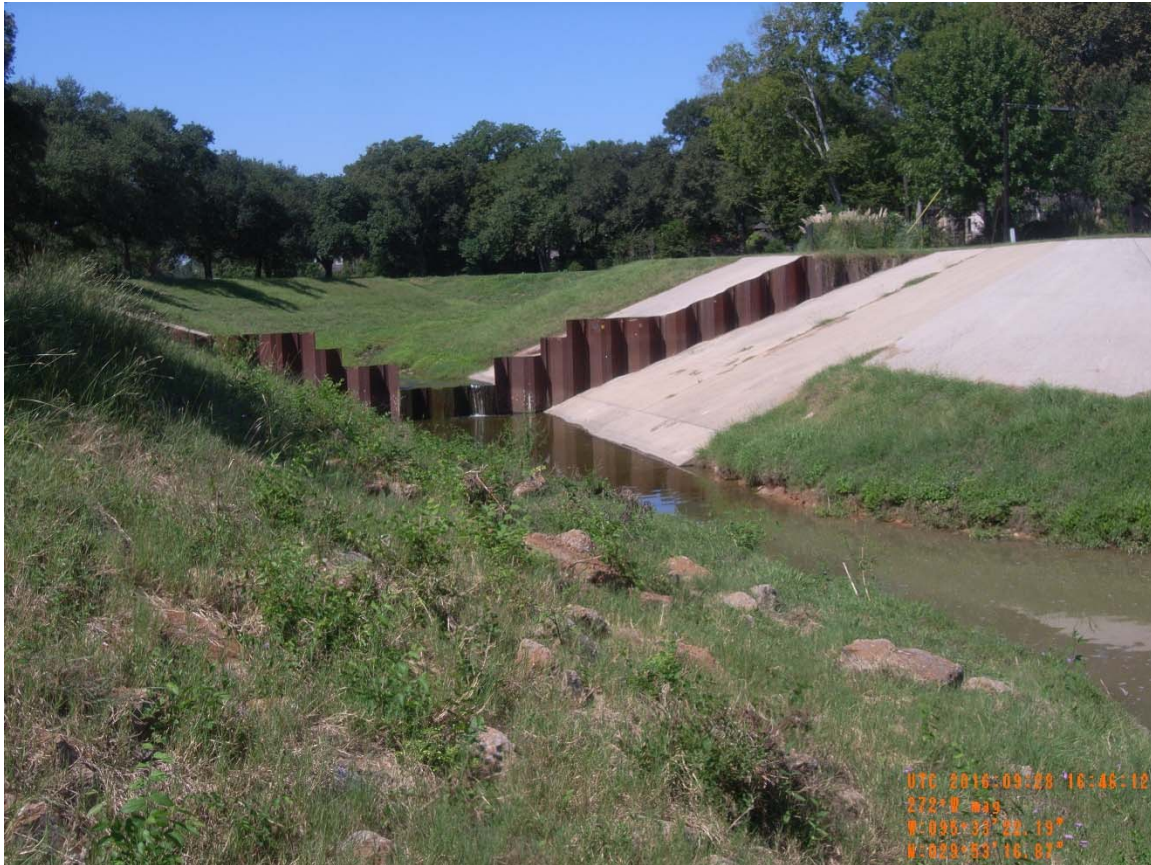
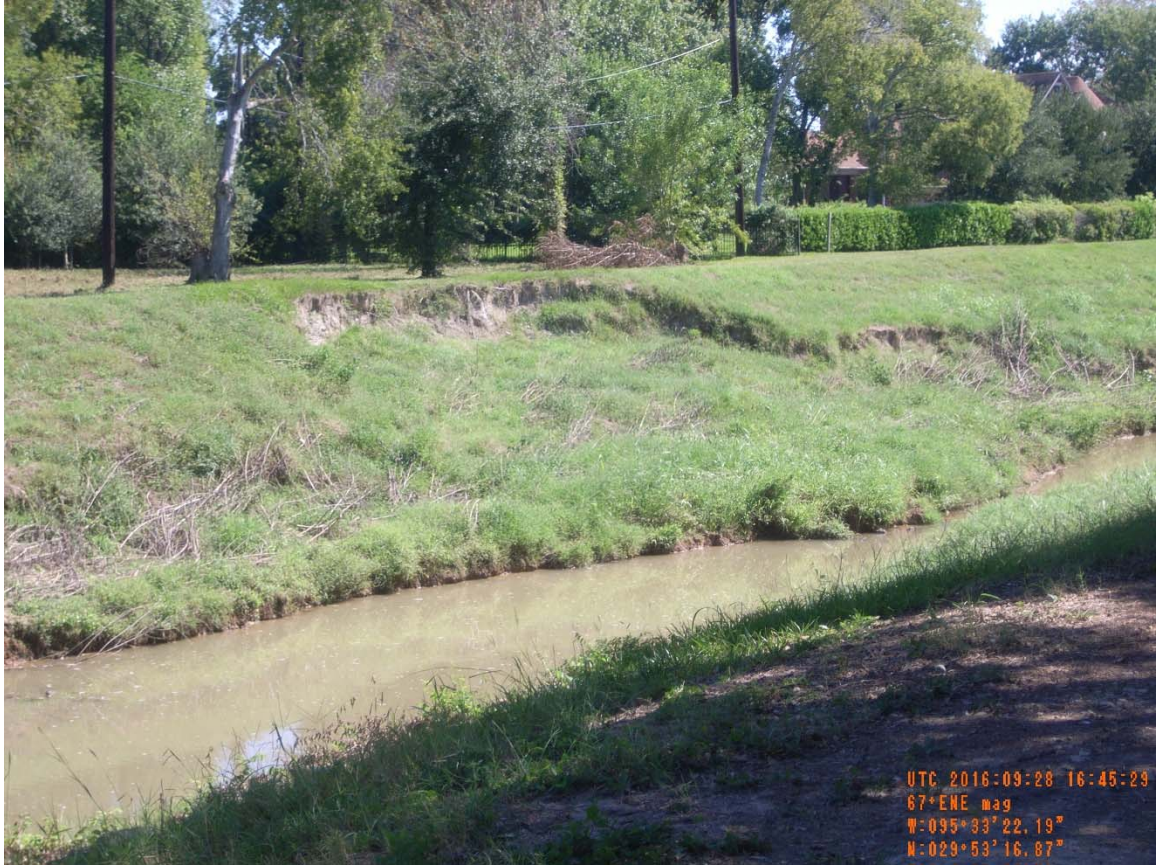
White Oak Bayou and E127-00-00 Junction

White Oak Bayou (E100-00-00) is forced to make a 90° bend at the junction with E127-00-00. A sheet pile drop structure is located immediately upstream of the junction and is perceived as a “choke point” by the public. The drop structure will be analyzed during the project to determine if it causes flow to back up during extreme events.

Approximately 300’ downstream of the junction, the slope on the left side of E100-00-00 has failed. Possibly due to erosion in the bottom of the channel.

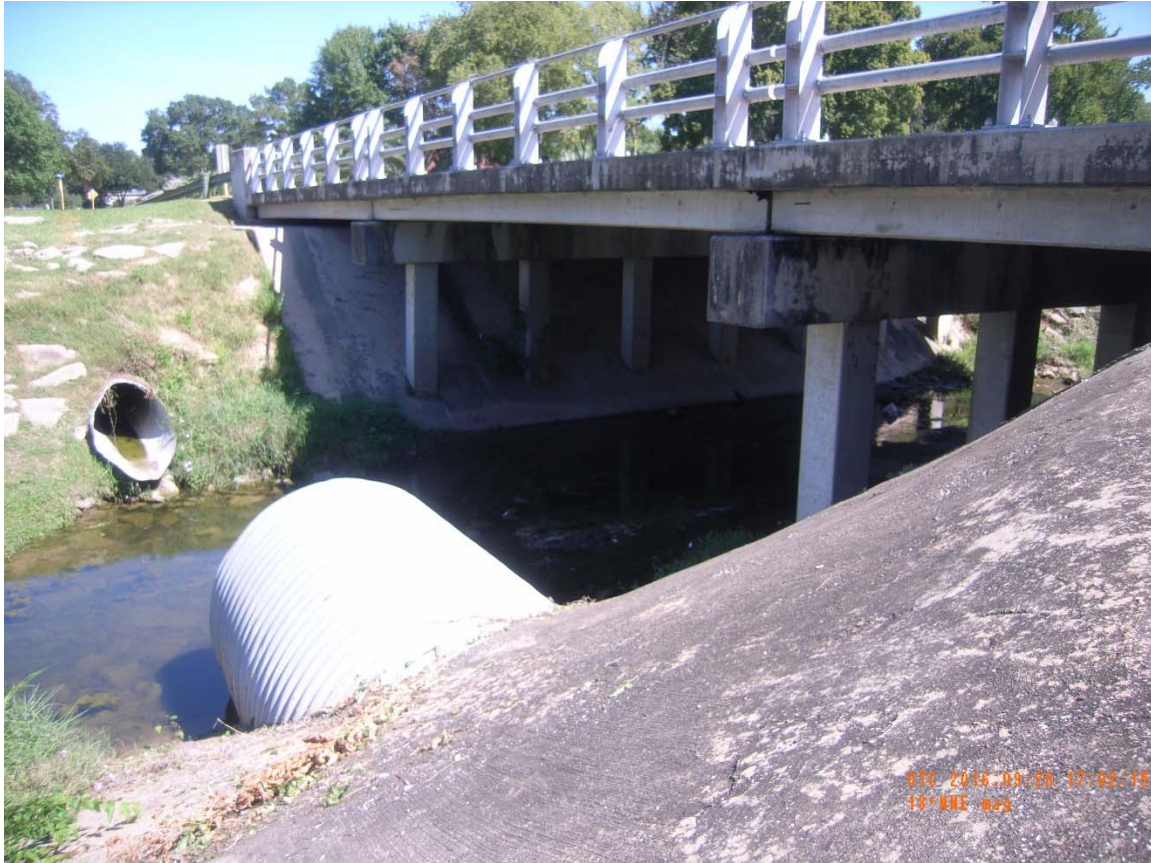
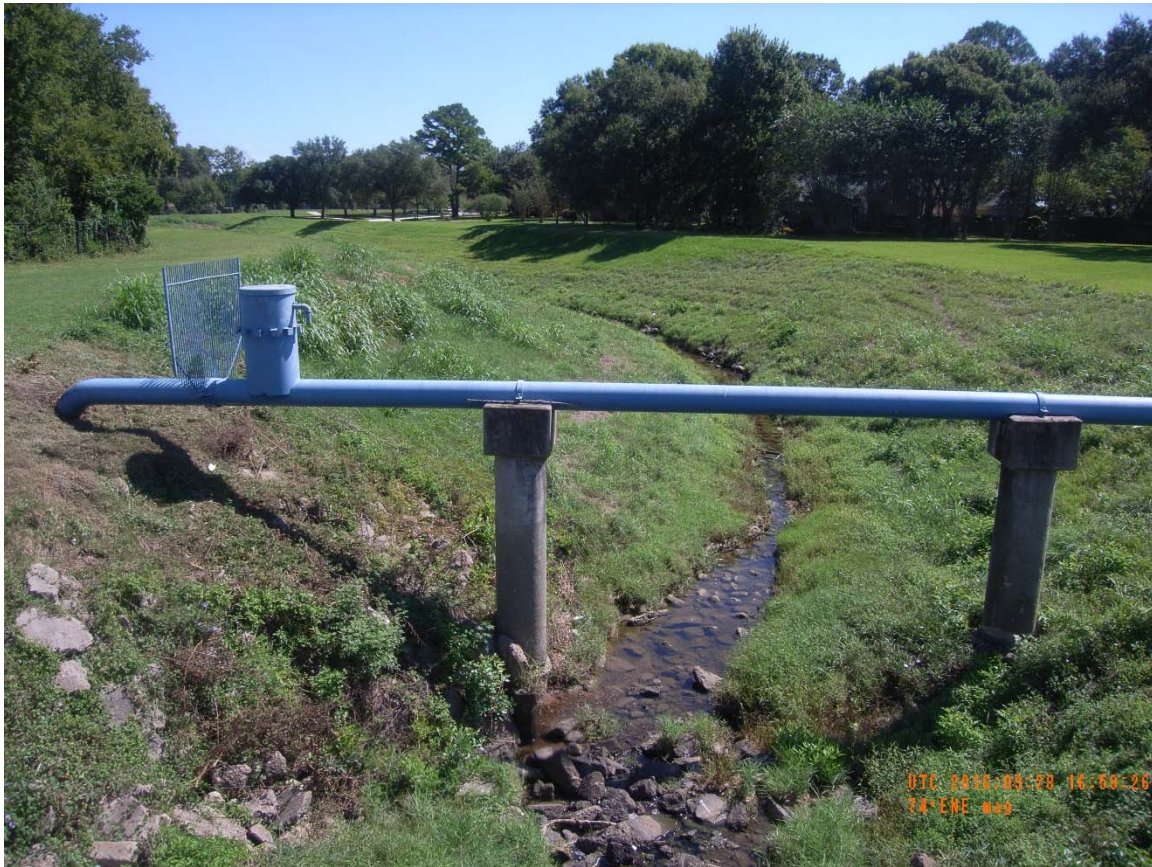
The Senate Avenue Bridge over E127-00-00 does not have columns in the bottom of the channel. However, there is a water line that crosses the stream on the downstream side of the bridge with one support column in the bottom of the channel.

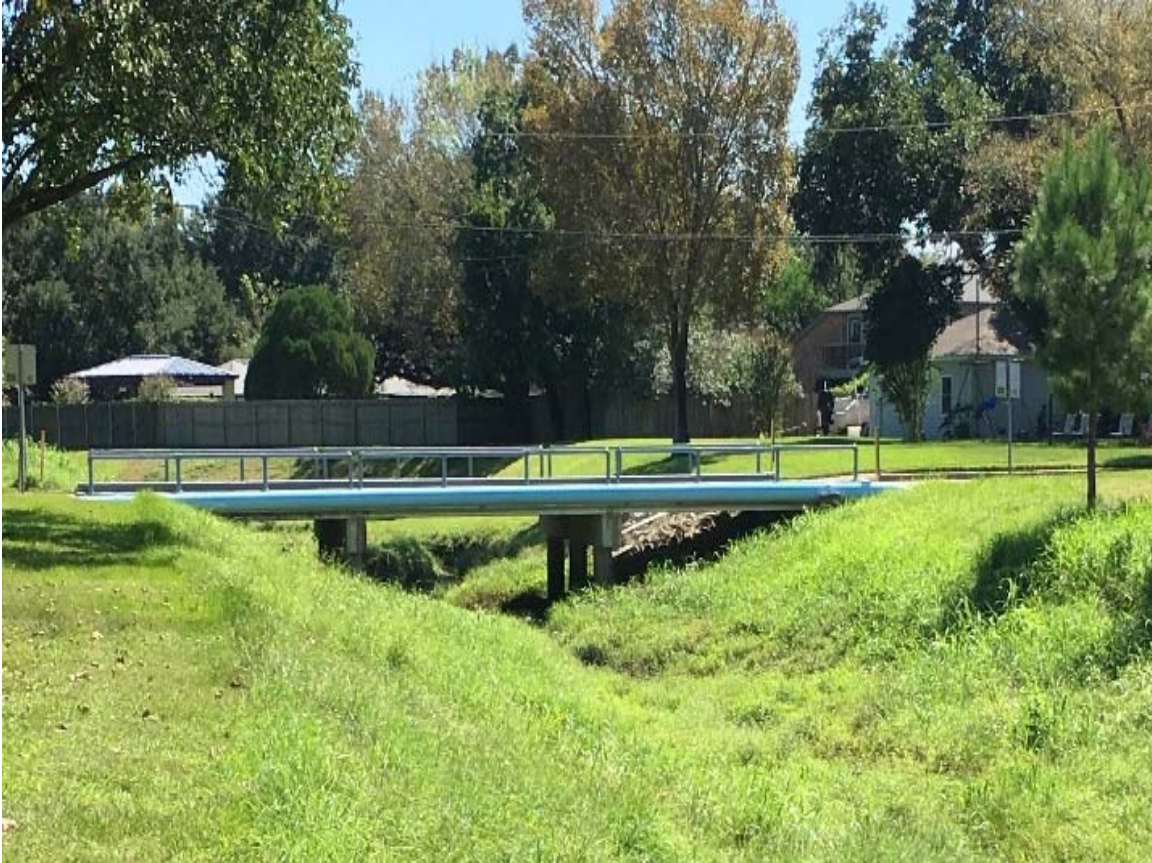
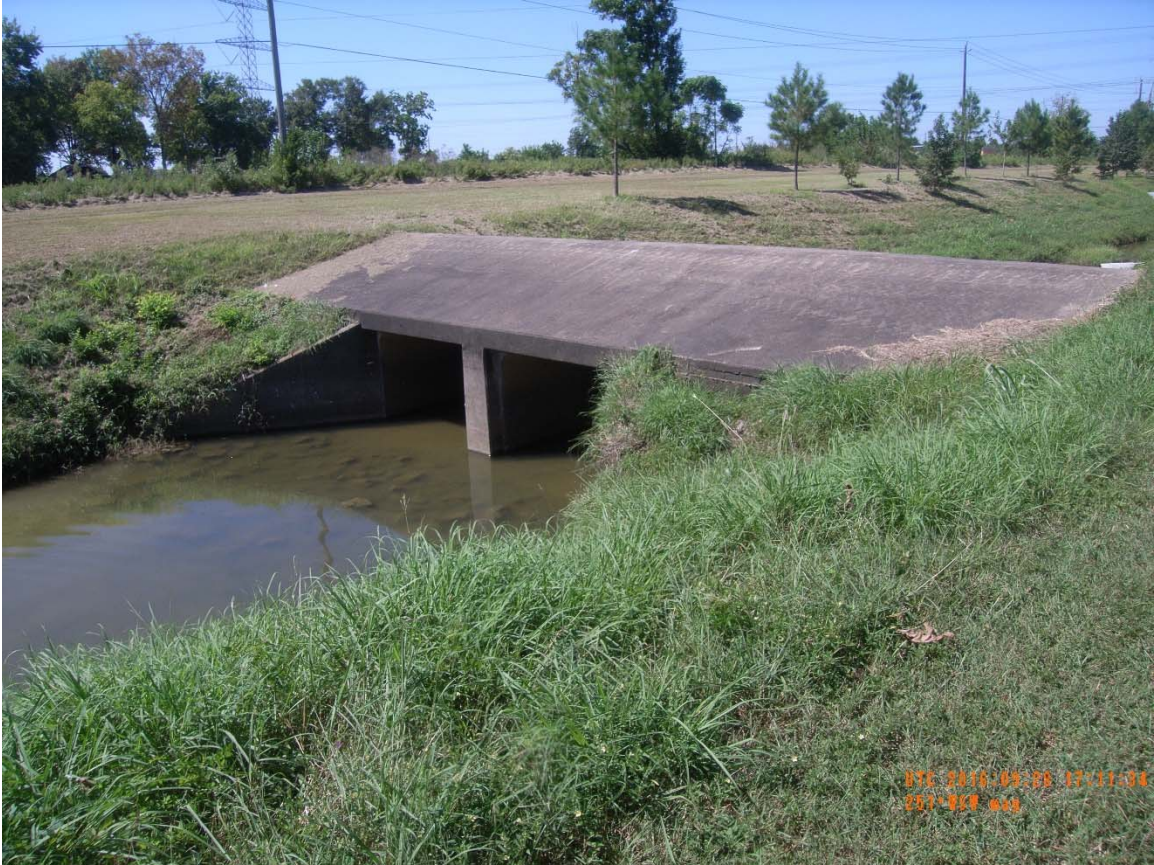
The Rio Grande Street Bridge over E127-00-00 appeared to have one set of columns in the bottom of the channel and has a water line attached to the bridge. The bridge did appear to have elevated approaches and will need to be checked for overtopping. Upstream of the bridge, box culvert restrictors had been placed in the channel.

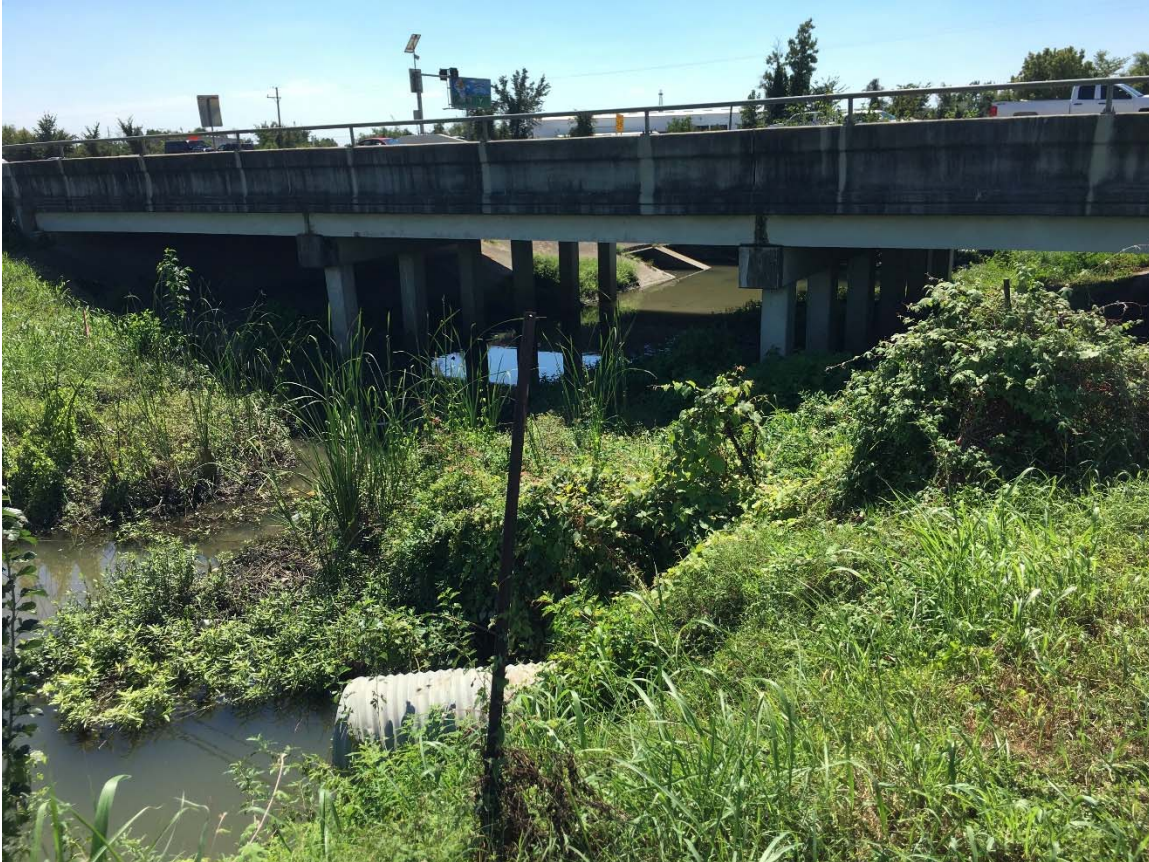
The US 290 Crossing over E127-00-00 has multiple bridges. The westbound frontage road bridge has one set of columns in the channel. Box culverts also outfall at the US 290 crossing.

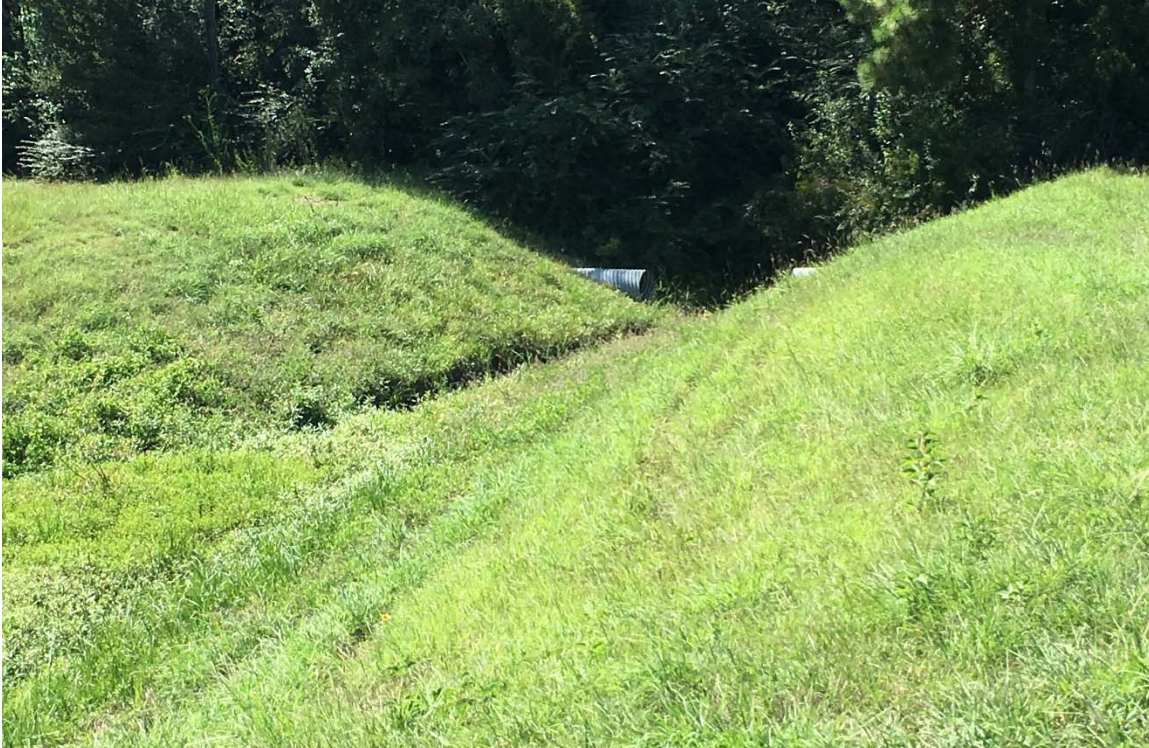
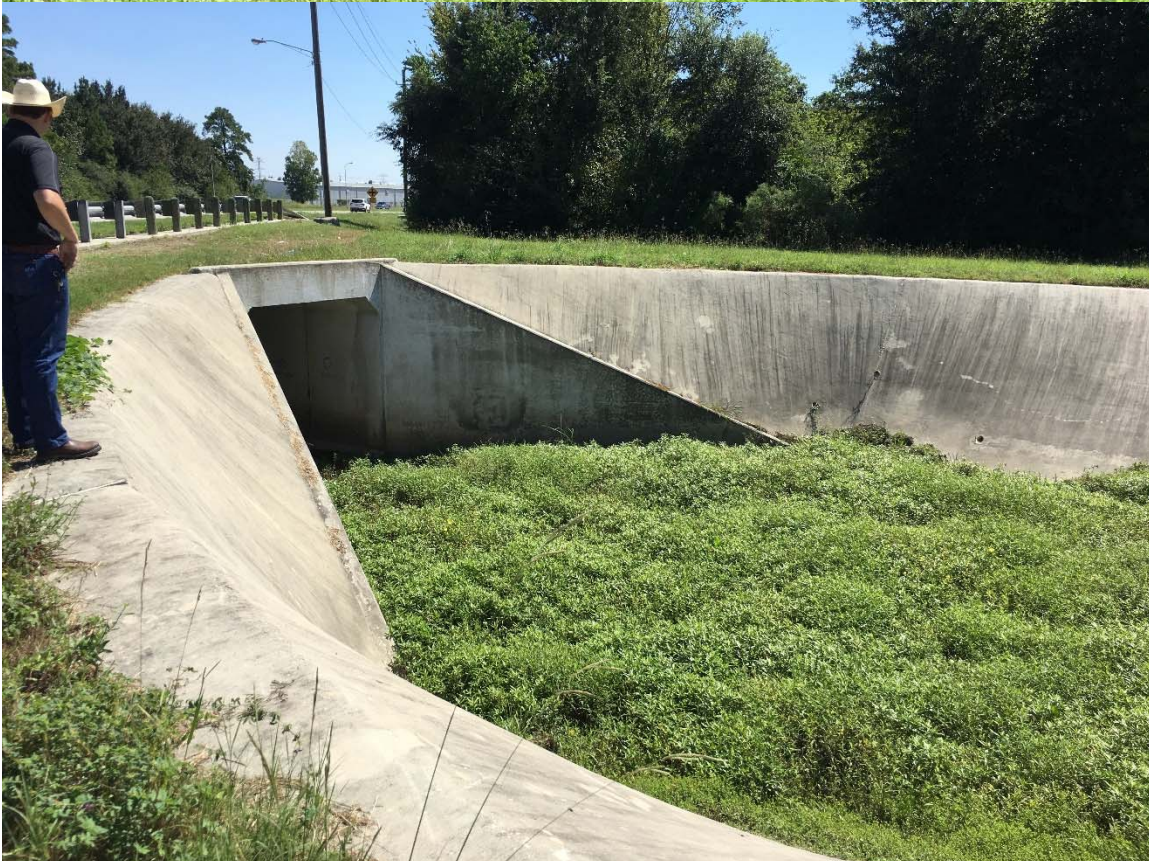
E127-00-00 Headwaters and Jones Road Crossing

The defined channel for E127-00-00 begins just west of the Jones Road crossing and is a well-maintained channel. Two pipes outfall into the channel at its headwaters on opposite sides. The Jones Road Crossing is a large box culvert with flared wing walls.

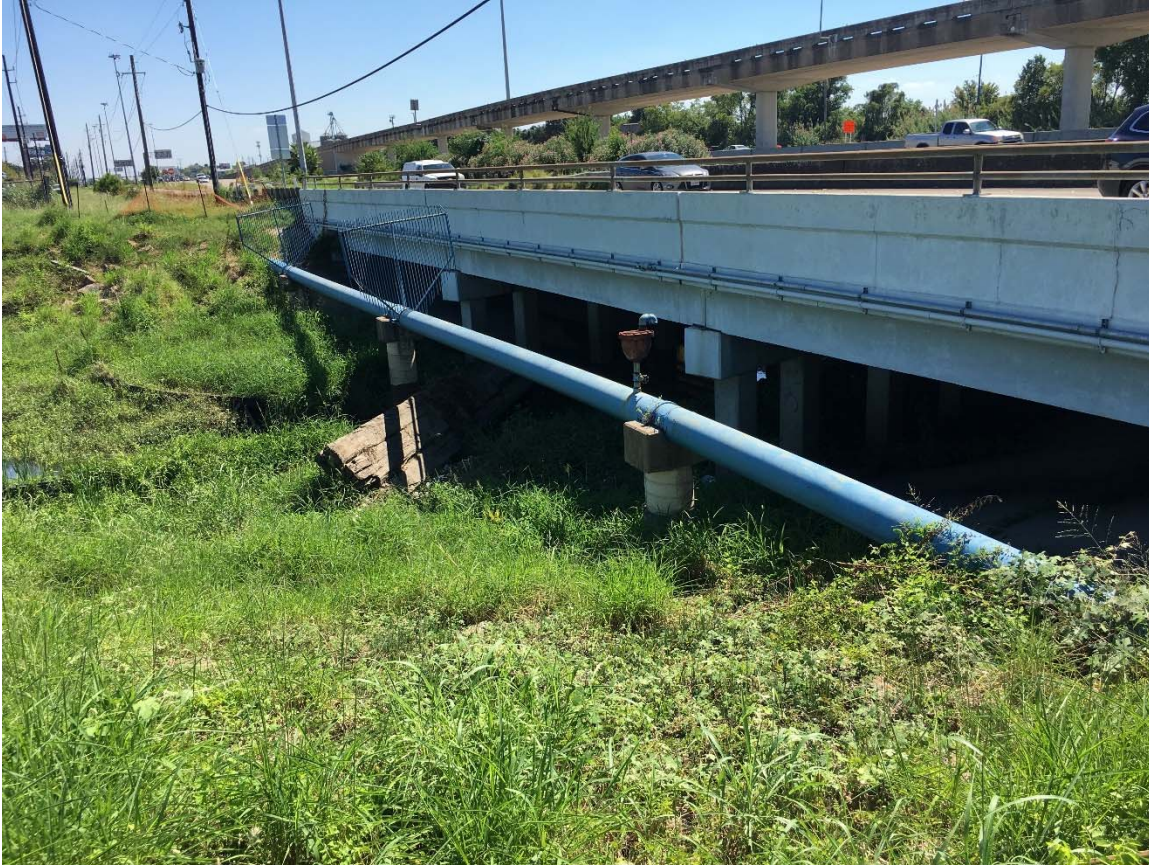
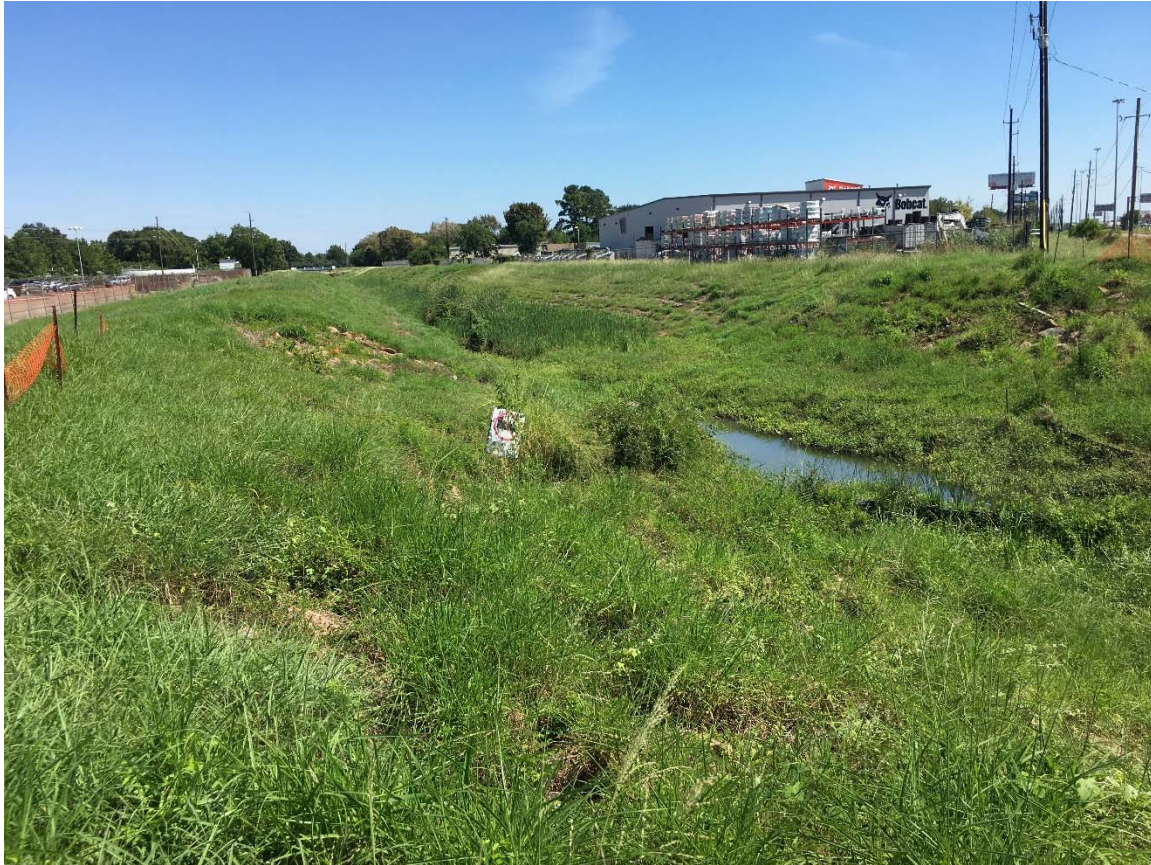
The US 290 Crossing over E135-00-00 has multiple bridges. A waterline is attached to the westbound frontage road bridge. The channel was choked with debris and in need of maintenance.

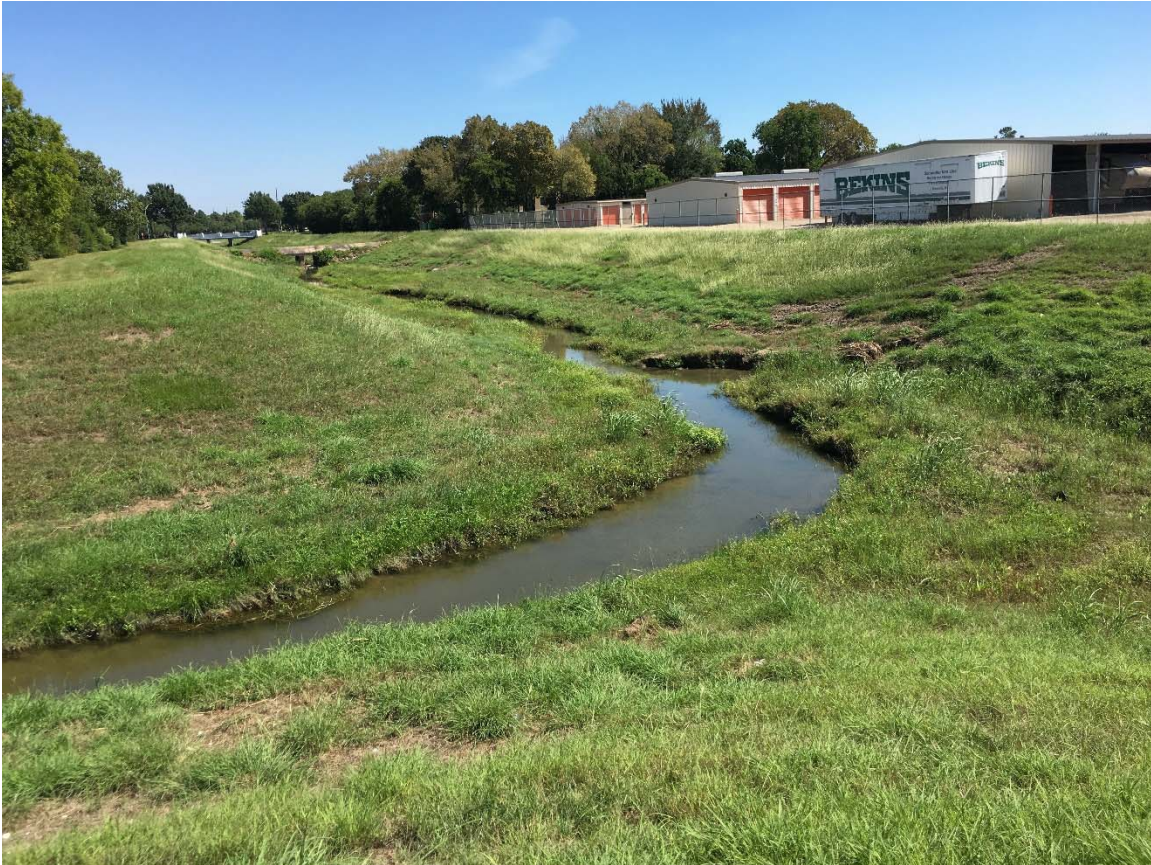
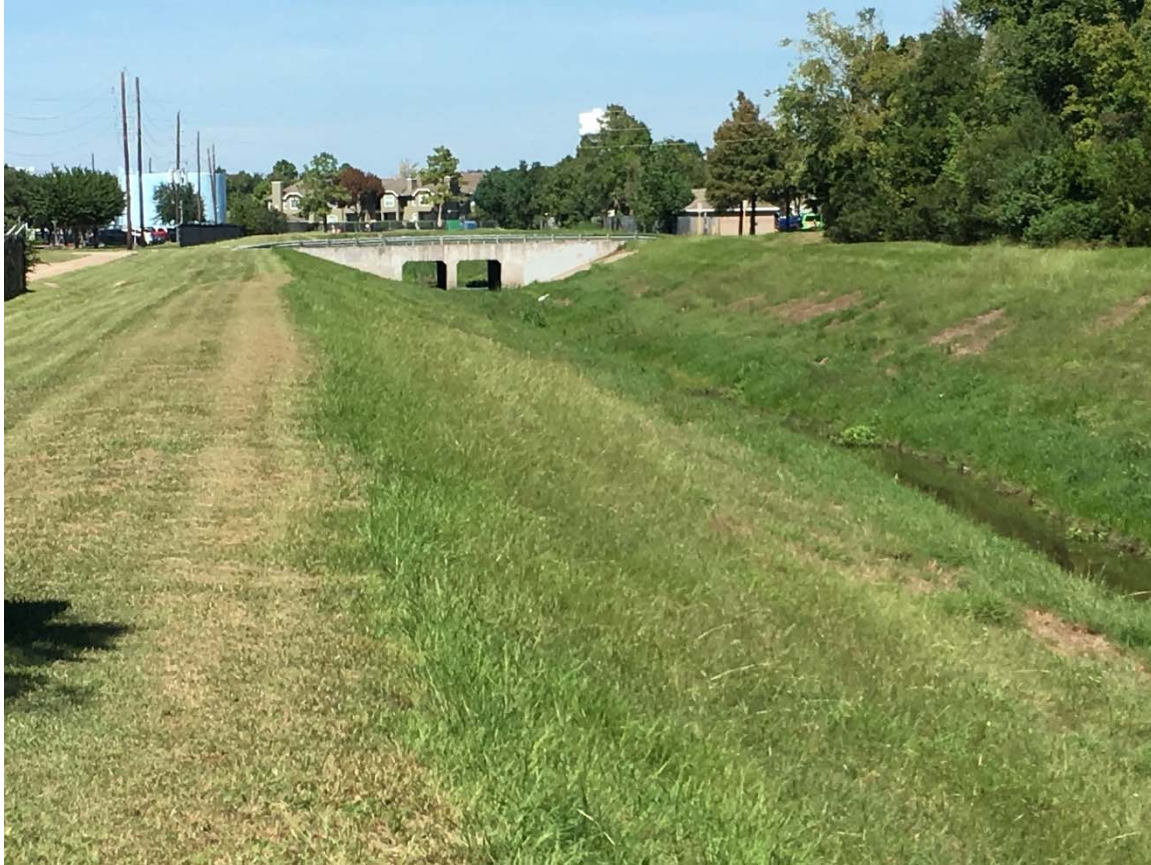
E135-00-00 Junction with Minor Tributary

The junction of E135-00-00 and one of its minor tributaries seemed to be functioning well. No erosion damage was observed. However, looking downstream on E135-00-00 another box culvert restrictor was observed in the channel. The restrictor is located upstream of the Steepleway Boulevard Bridge. Castlebridge Drive crosses over the tributary via box culverts.

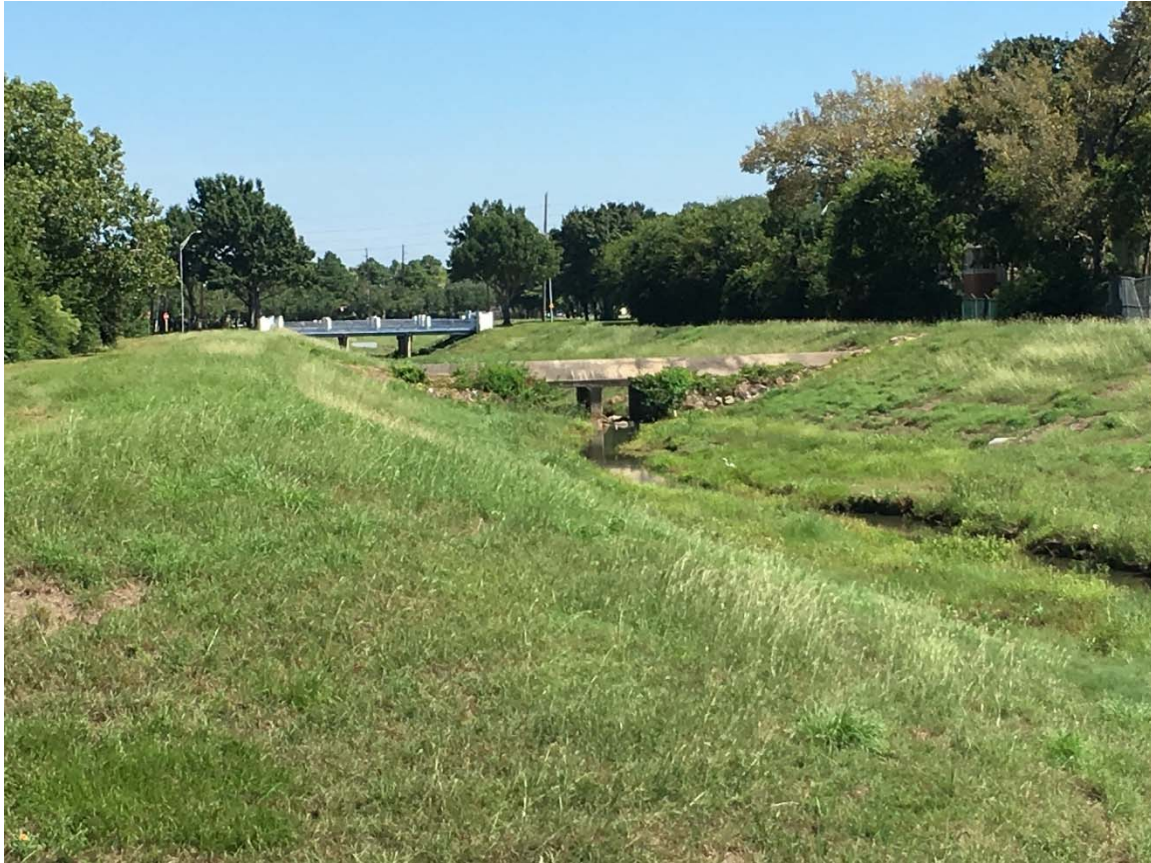
Steepleway Boulevard Bridge over E135-00-00

The Steepleway Boulevard Bridge is two separate bridges. A waterline is attached to the western (southbound) bridge. The bridges' columns are also placed in the bottom of the channel. The bridges are not perpendicular to the channel, meaning that the columns were placed on a skew.

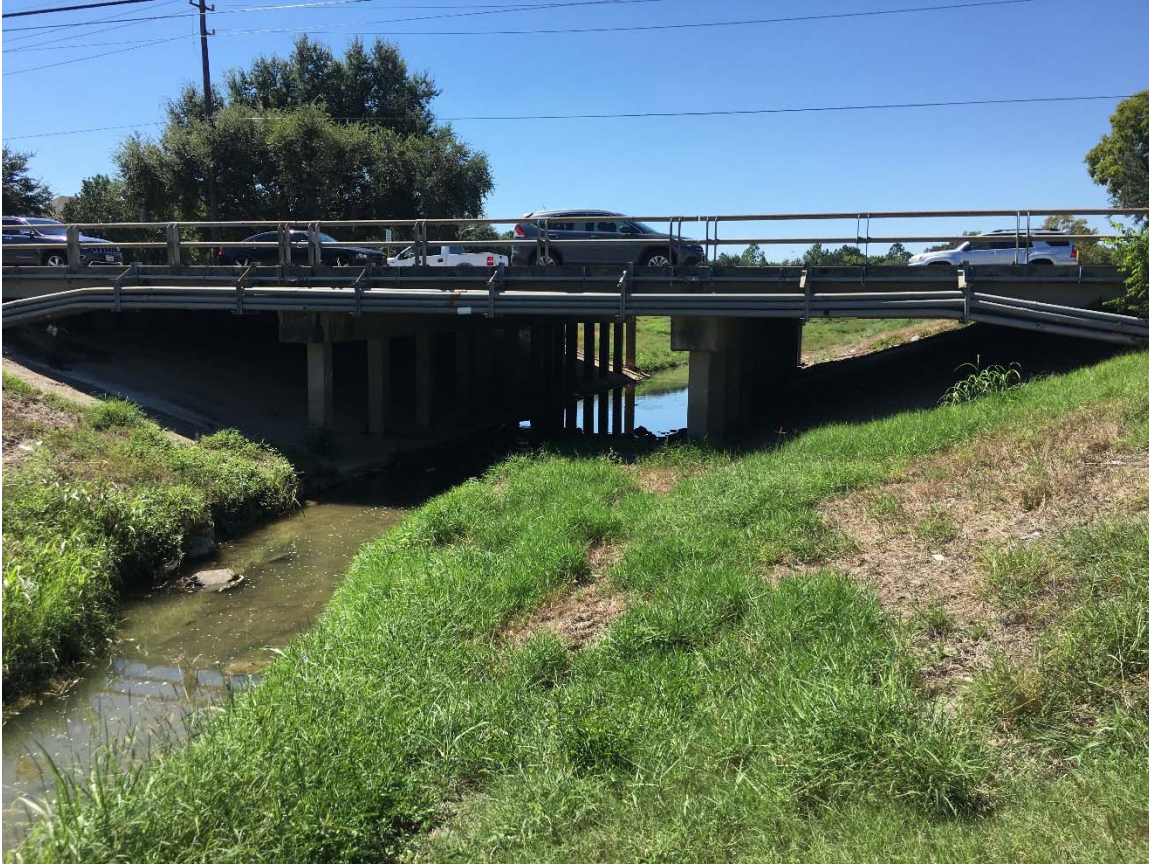
Jones Road Bridge over E135-00-00

The Jones Road Bridge has a waterline attached to the western side and other utilities attached to the eastern side. The crossing is a single bridge, with minimal to no skew compared to the channel. The bridge columns are not in the bottom of the channel.

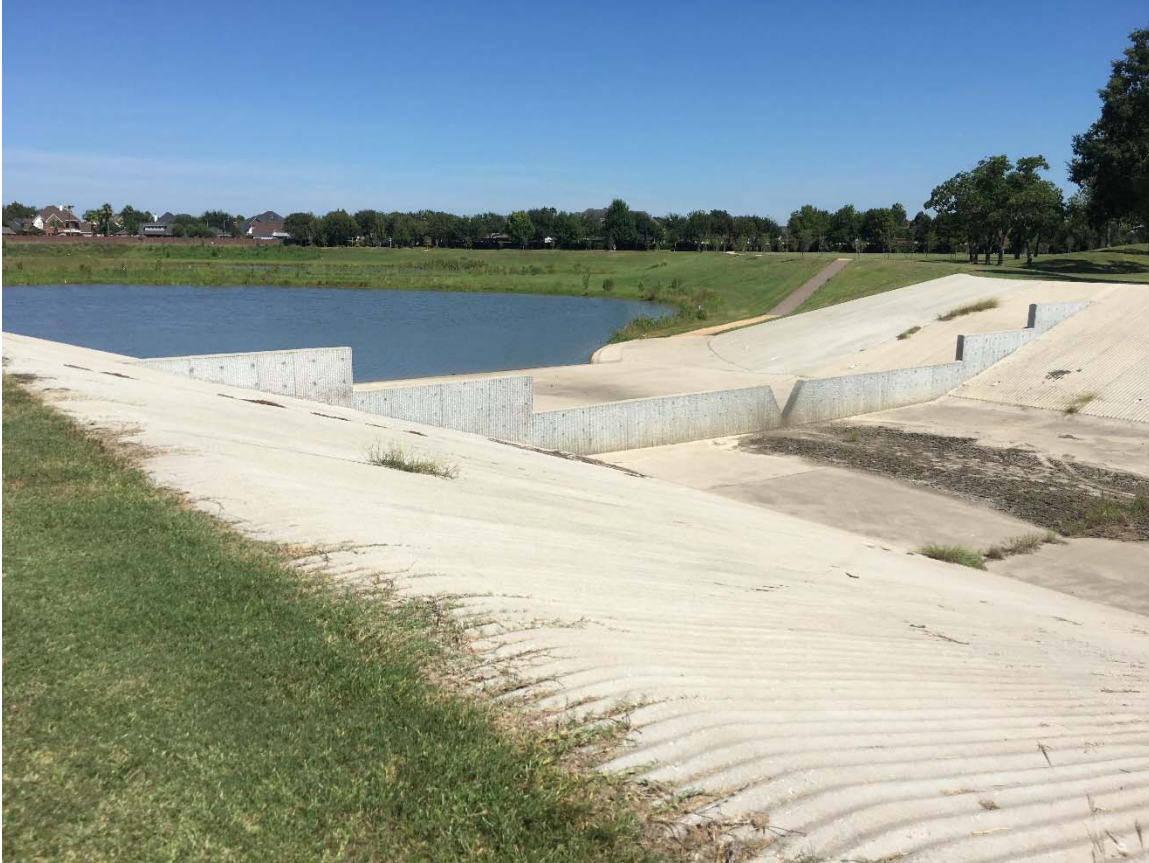
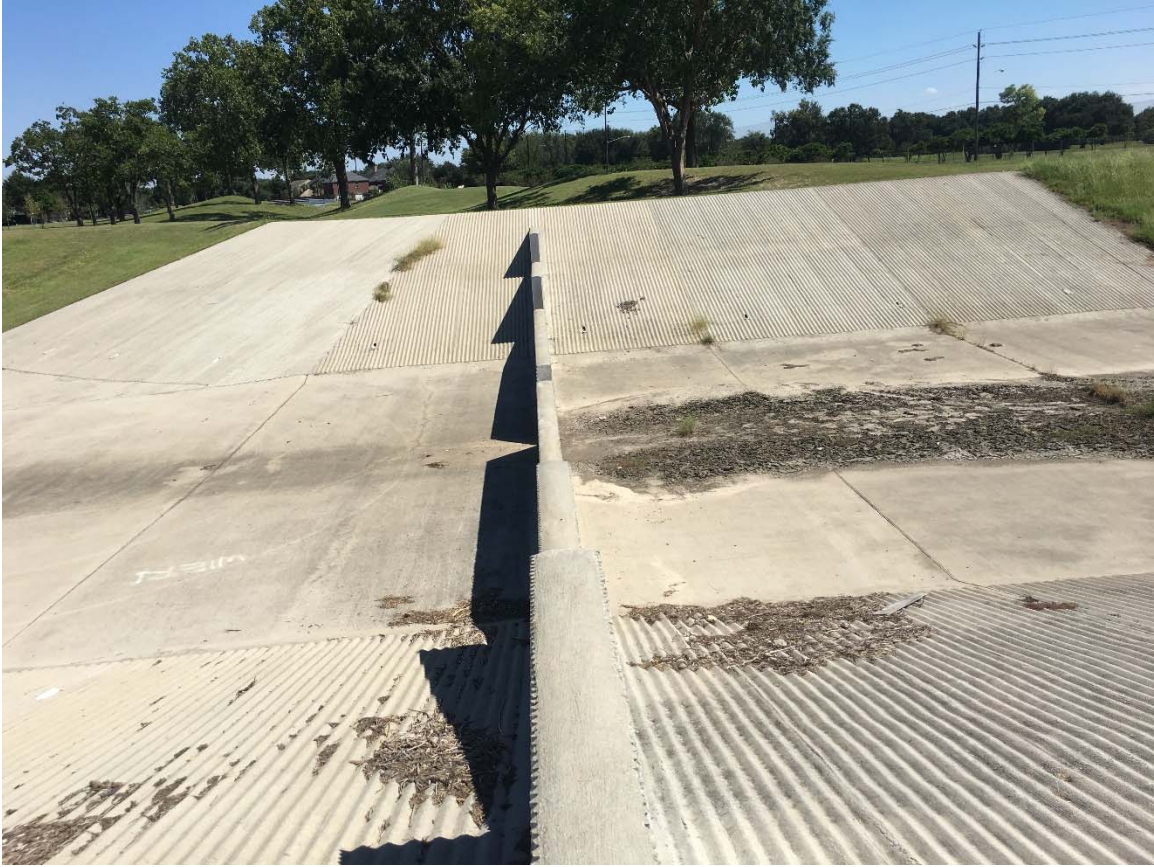
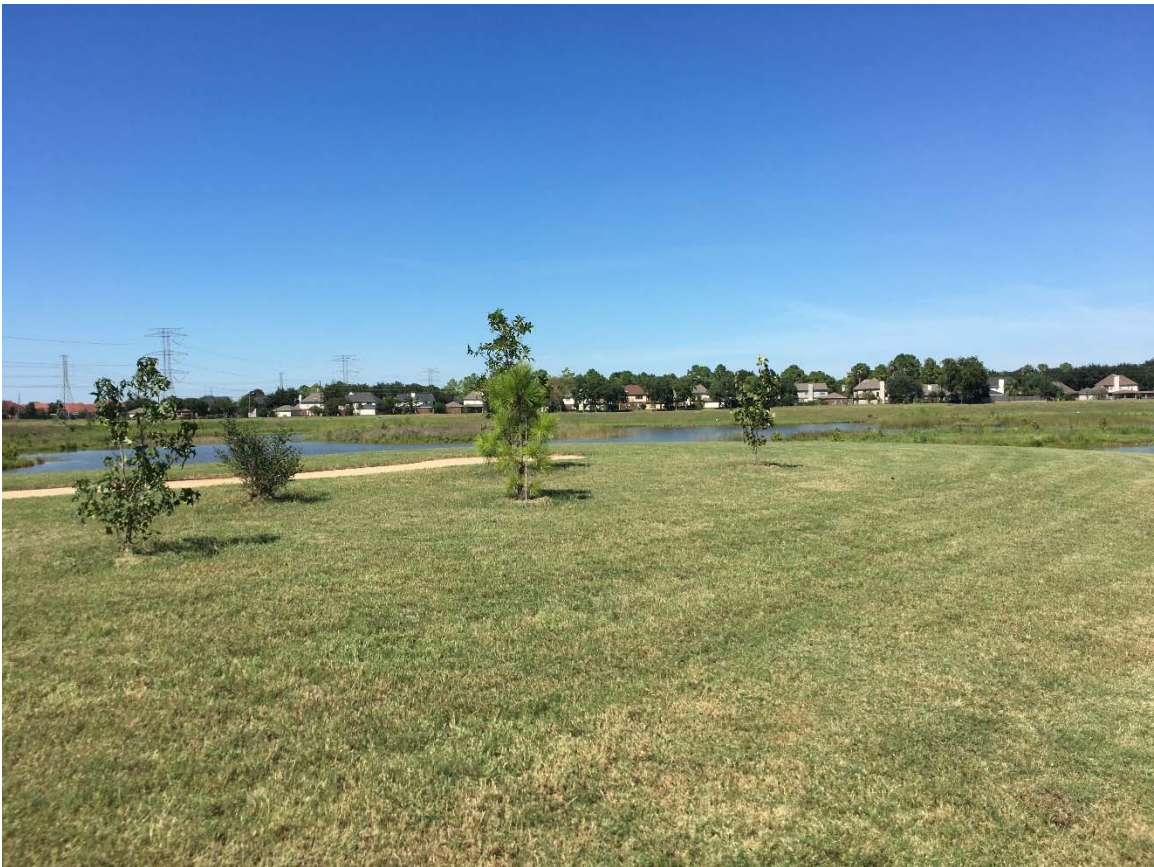
The E535-01-00 Stormwater Detention Basin has a permanent water surface elevation, has functioning wetlands, and has a large multi-frequency weir outlet structure. The City provided a copy of the study, and the plans for the Basin will be requested from HCFCO.
