Field Visit Summary Report
City of Jersey Village
Wednesday, September 28, 2016
11:00AM – 3:30PM

General Summary

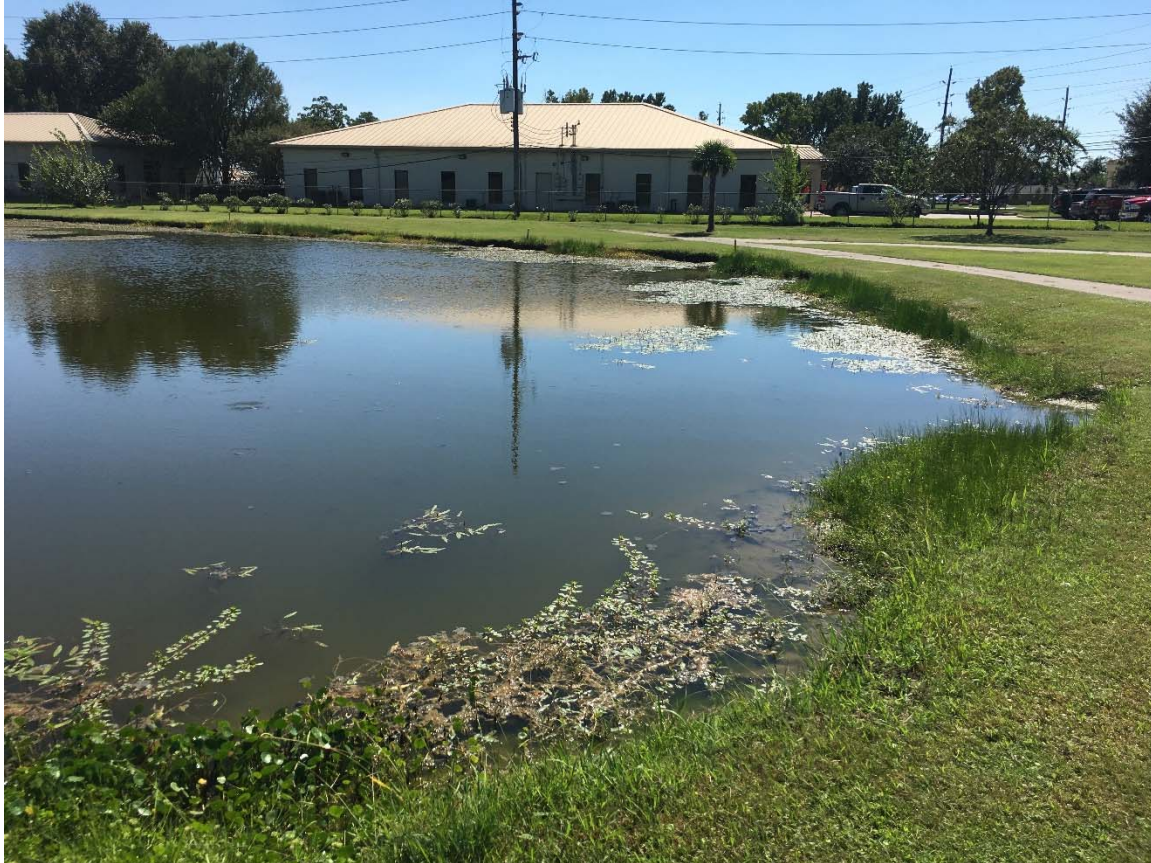
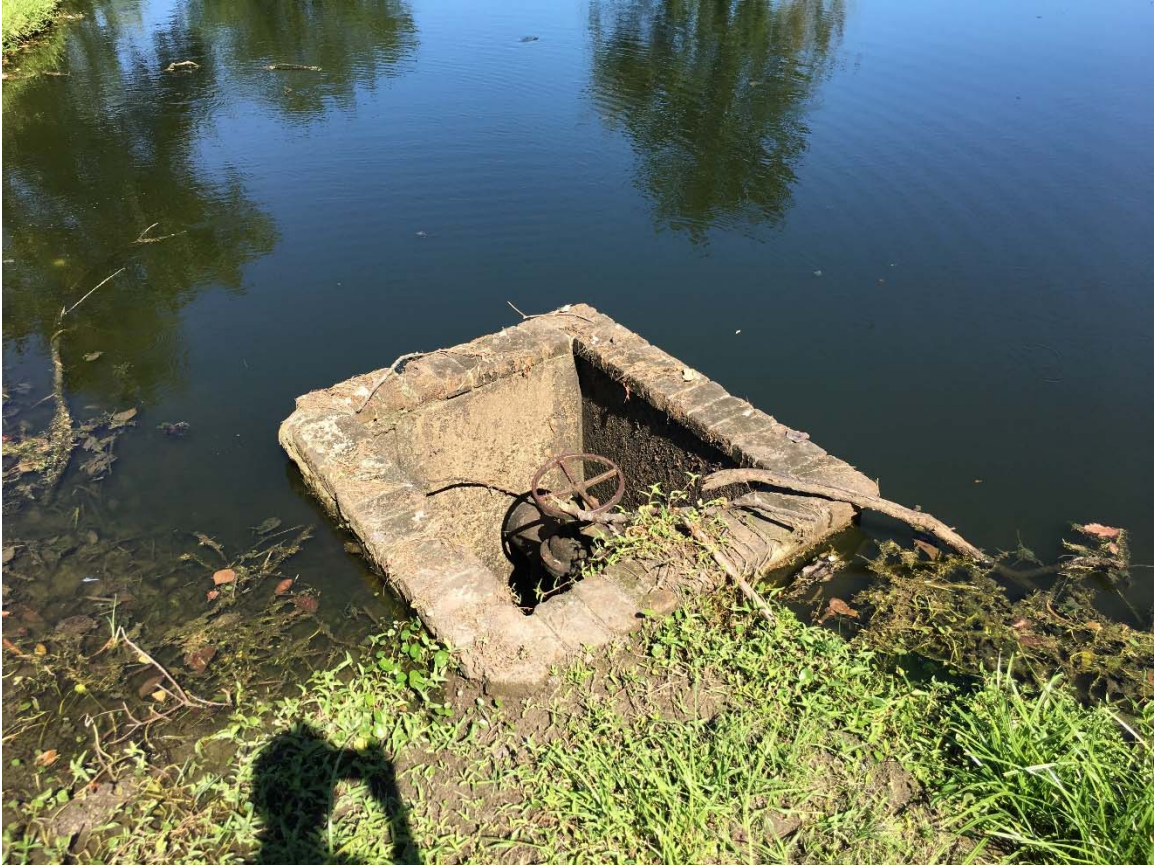
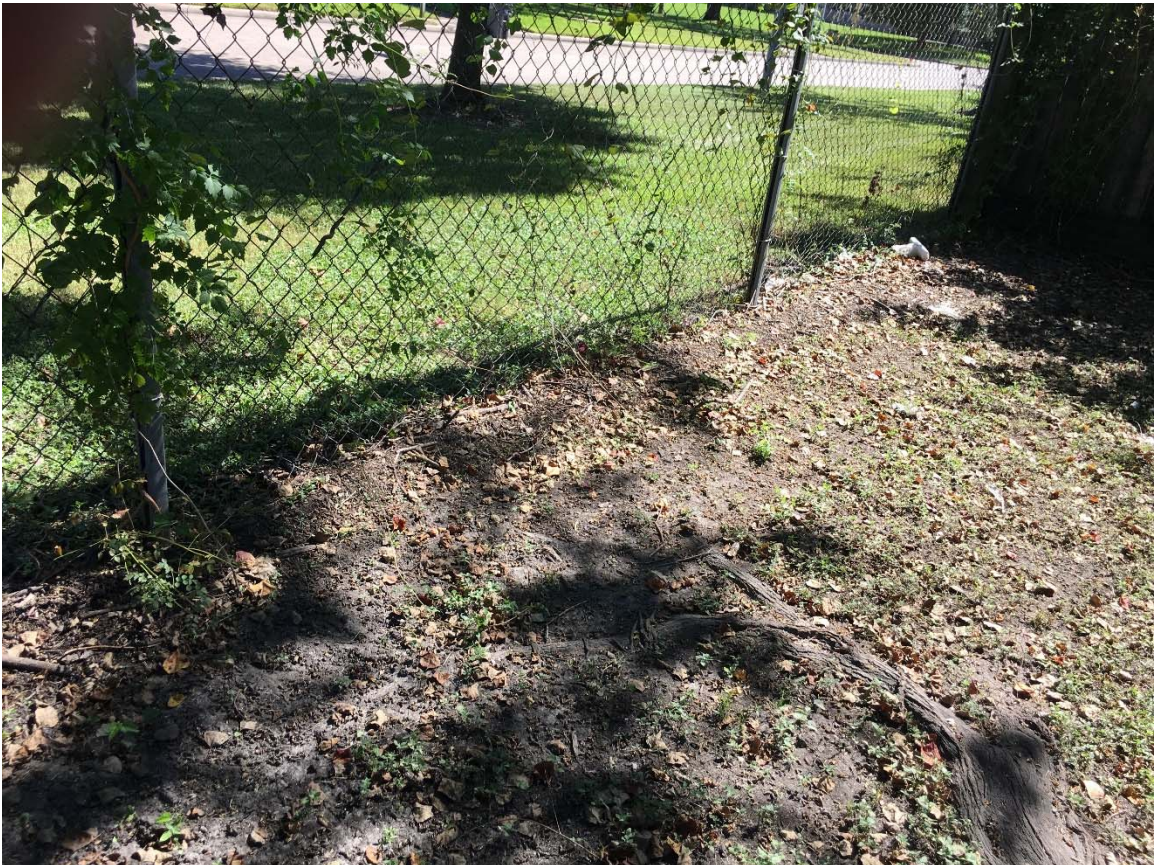
Jersey Meadow Golf Course

The Team took a tour of the Golf Course to look at the drainage patterns. The highest elevation water feature was located at hole 14. In general, the golf course drains from west to east. The eastern edge of the golf course sheet flows onto Rio Grande Street. The sheet flow is the largest near the intersection of Rio Grande Street and Wall Street. Debris was observed at the fence on the eastern side of the Golf Course.

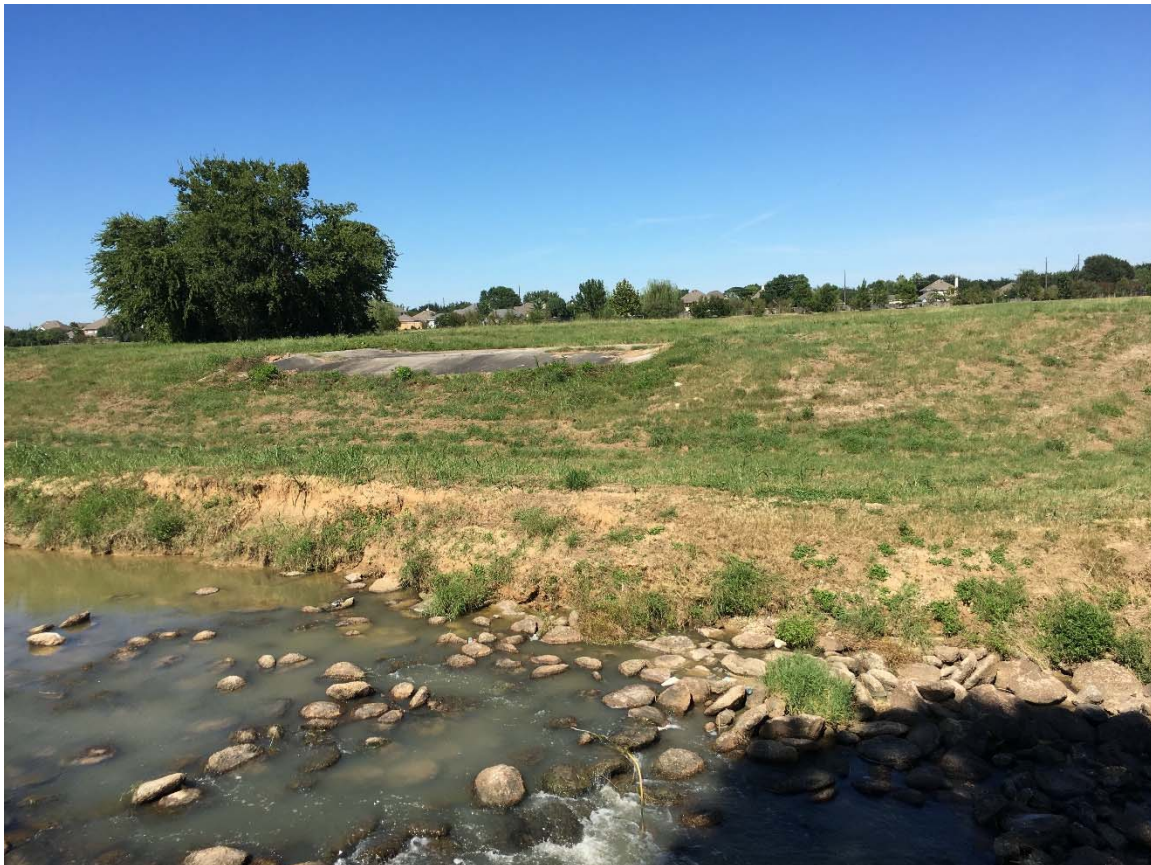
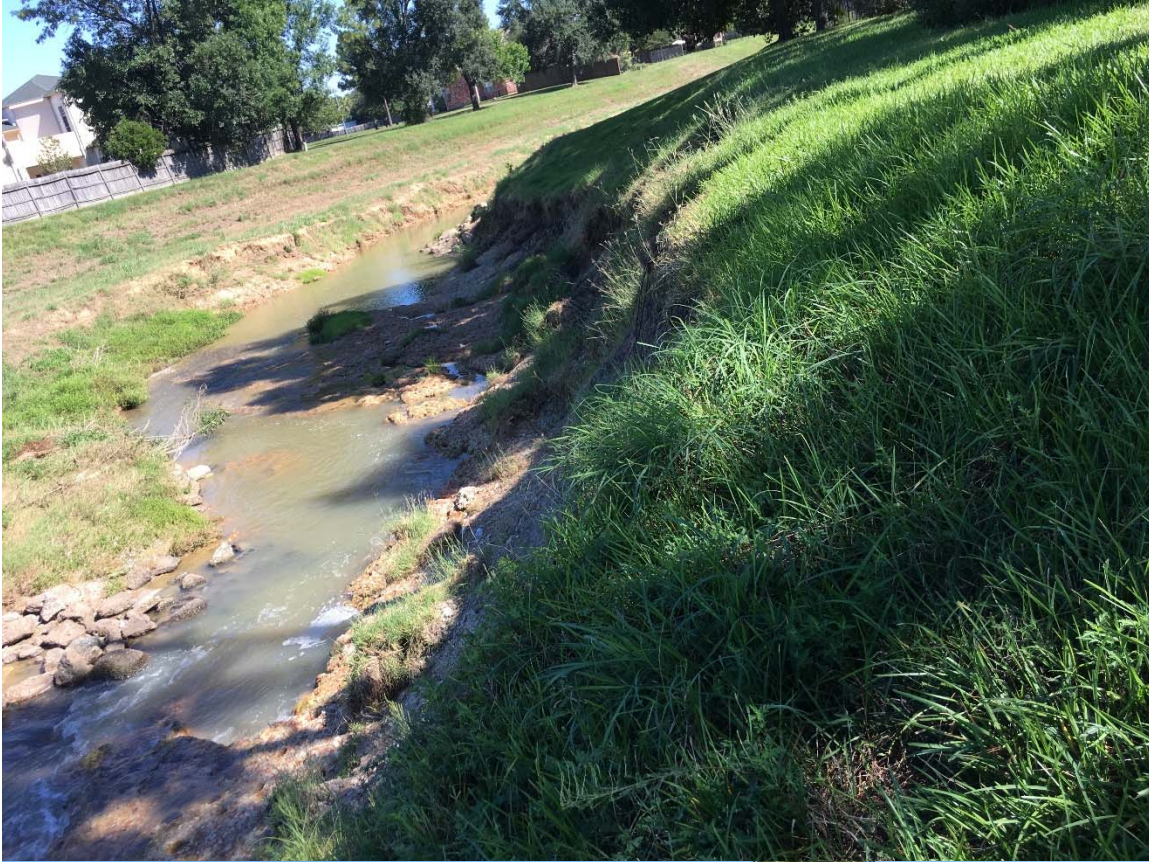
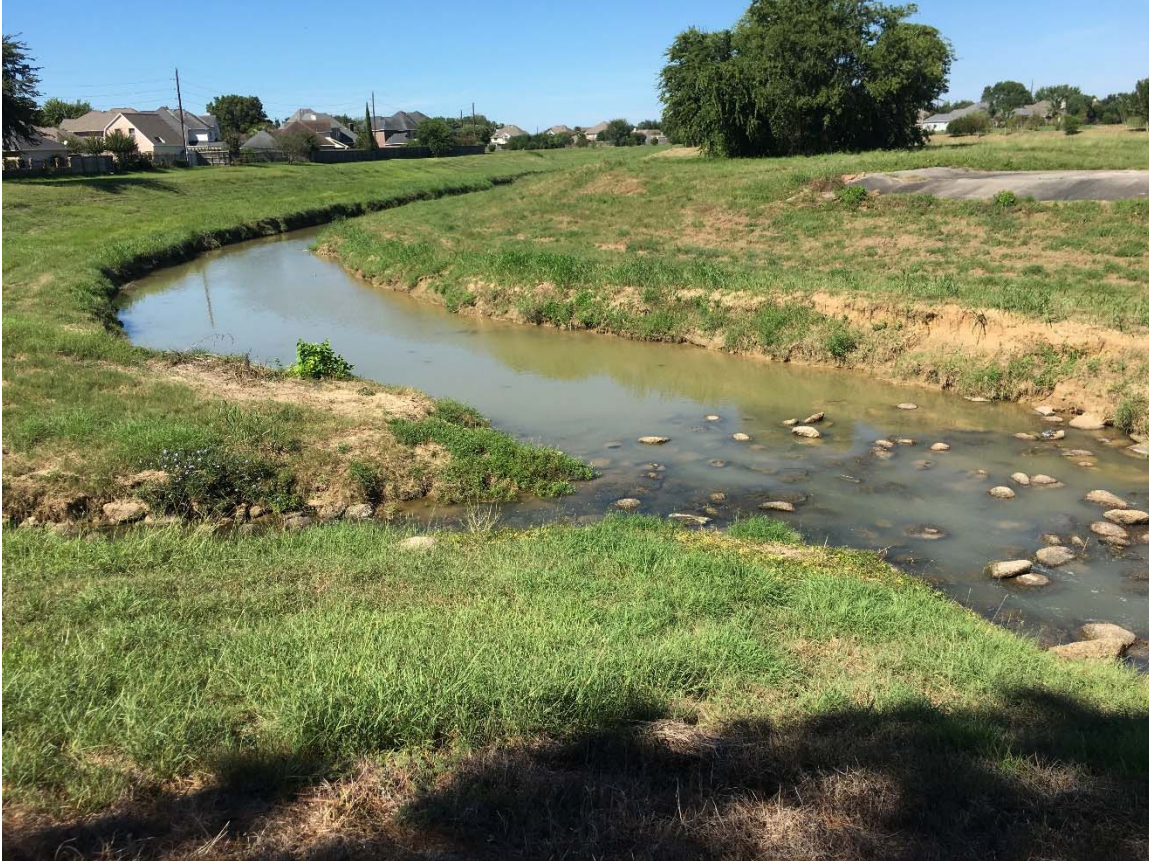
White Oak Bayou, Bypass, and E135-00-00 Junction

The stream junction at White Oak Bayou (E100-00-00), the White Oak Bayou Bypass (E200-00-00), and E135-00-00 is a unique stream feature. E135-00-00 does not connect directly to the Bypass. The Bypass splits from White Oak Bayou immediately upstream of E135-00-00. An old concrete weir was observed at the junction with no apparent purpose. Severe erosion has been occurring along the right bank of White Oak Bayou downstream of the junction since before the Tax Day Flood.

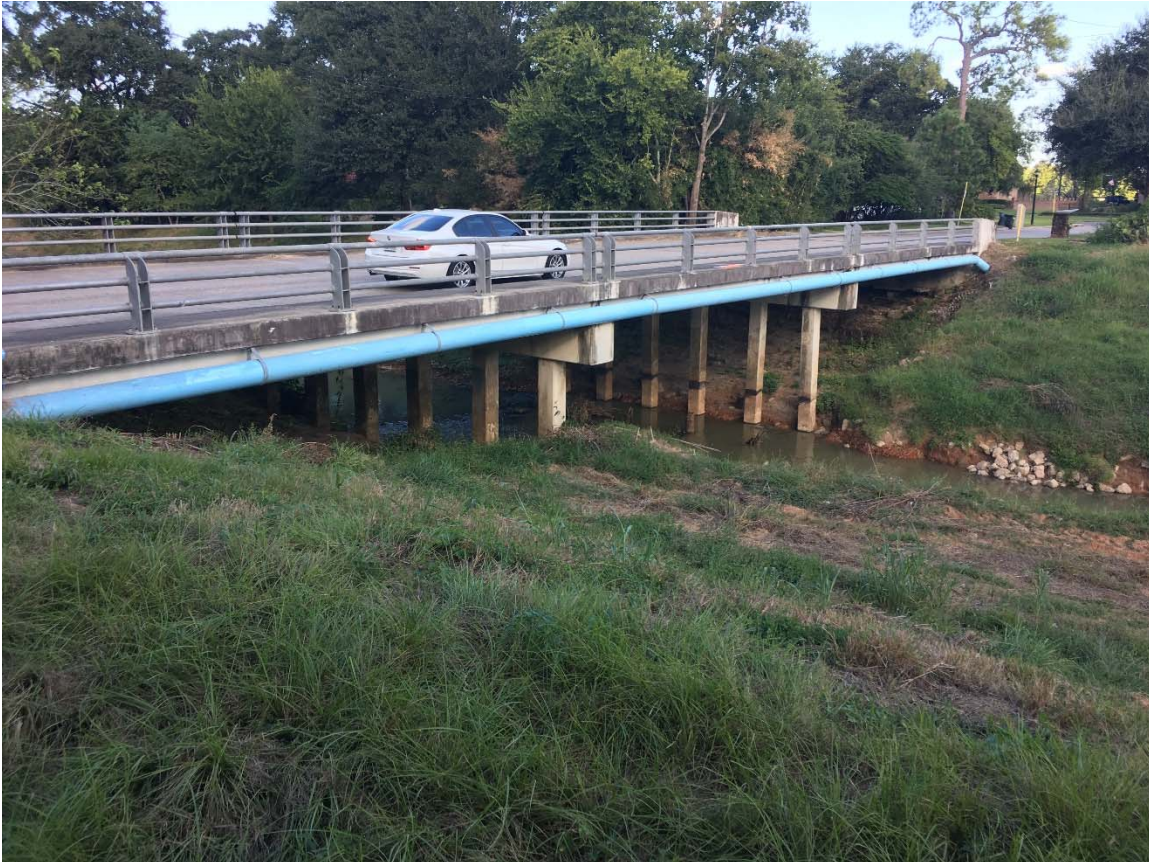
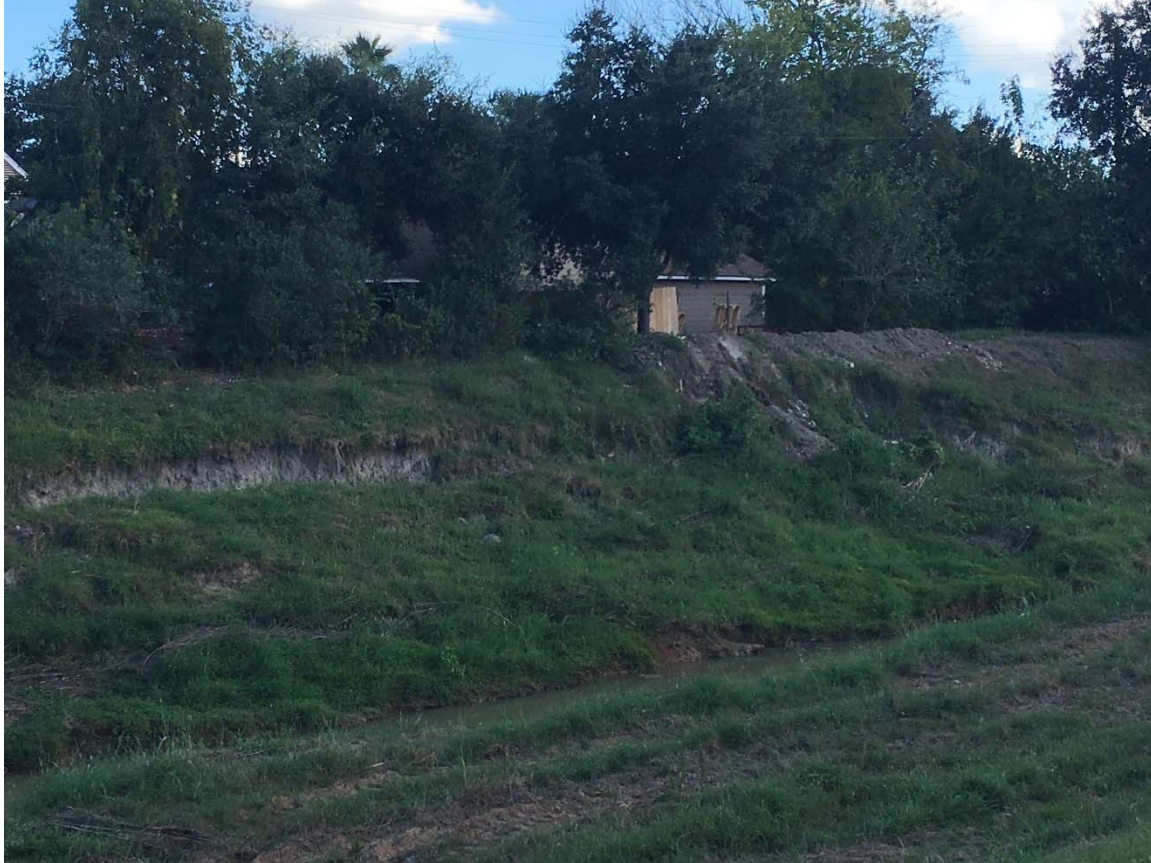
Tahoe Drive Bridge over White Oak Bayou

The Tahoe Drive Bridge was visited after the main field visit. It is located upstream of the junction of White Oak Bayou and E127-00-00. A waterline is attached to the bridge on the south side. One set of columns is on the edge of the channel bottom. Slope failures have occurred immediately downstream of the bridge on the left side of the channel. These slope failures are similar to those observed downstream of the junction of White Oak Bayou and E127-00-00.
